Atwater Kent model 20 big box, serial number 54384: restoration and test

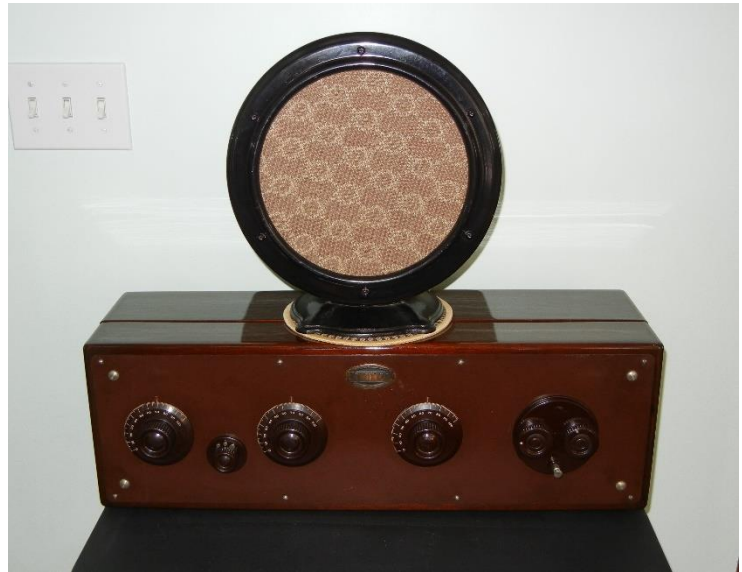
1. The mahogany box has been repaired and varnished. In order to keep the original varnish color when sanding, several layers of lacquer were painted first over the original wood case. All scratches were filled with varnish, and after carefully sanded before applying the last layers of varnish. The back of the radio the varnish has been fully removed due to deep scratches. The wood has been colored with **Mahogany red** and **cabernet** wood finish penetrating stain in several layers, in order to better fit the original color on the sides and top.
2. Only few scratches are visible on metal panel, it was cleaned and repaired partially using a thin permanent marker.

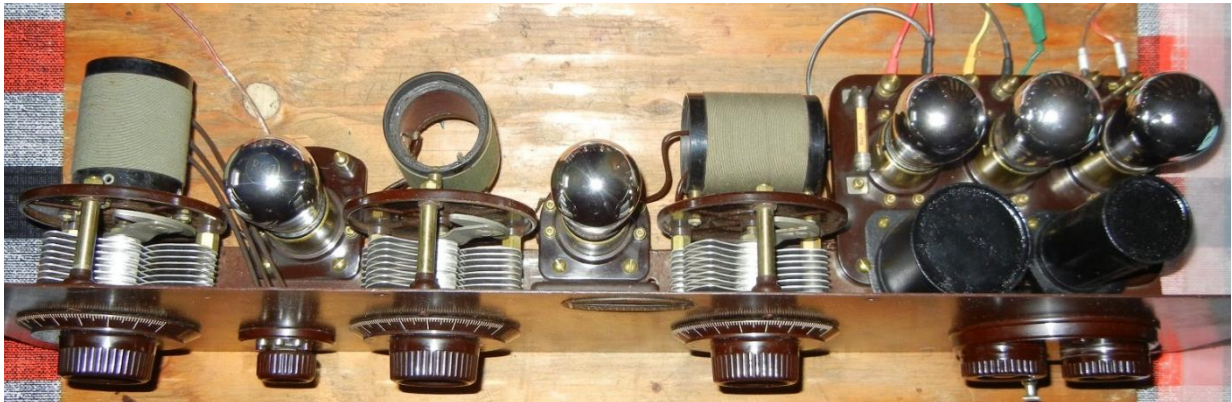
1. Both AF amplifying transformers were not functioning, 1<sup>st</sup> both primary and secondary open; 2<sup>nd</sup> transformer the secondary was open. The first transformer has been replaced with a 1000  $\Omega$ /7000  $\Omega$  transformer for old stock. The second with same with the one of the original ratios, 1700  $\Omega$  / 3250  $\Omega$ . I put the transformers in this order as in the schematic of later model 20 C with new sockets. Because they cannot fit in original place both were positioned a bit away, 2 holes for each were done in the brown textolit for fixation. For upside looks perfect.

2. The second grid resistor was open, I repaired as usual, short-circuiting and adding in series a 560  $\Omega$  carbon one under the black shrink tubing to keep appearance of original.

3. The 300 nF capacitor connected between the + 90 V and ground was disconnected. Usually, it is under the chassis. It was replaced by a modern one 300 nF/100 V.

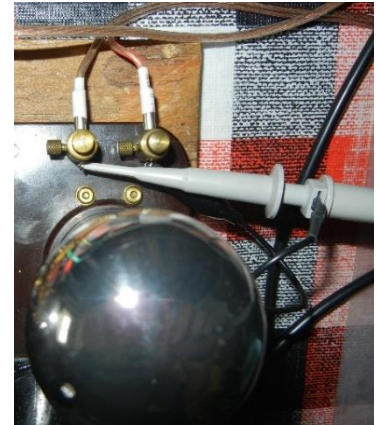
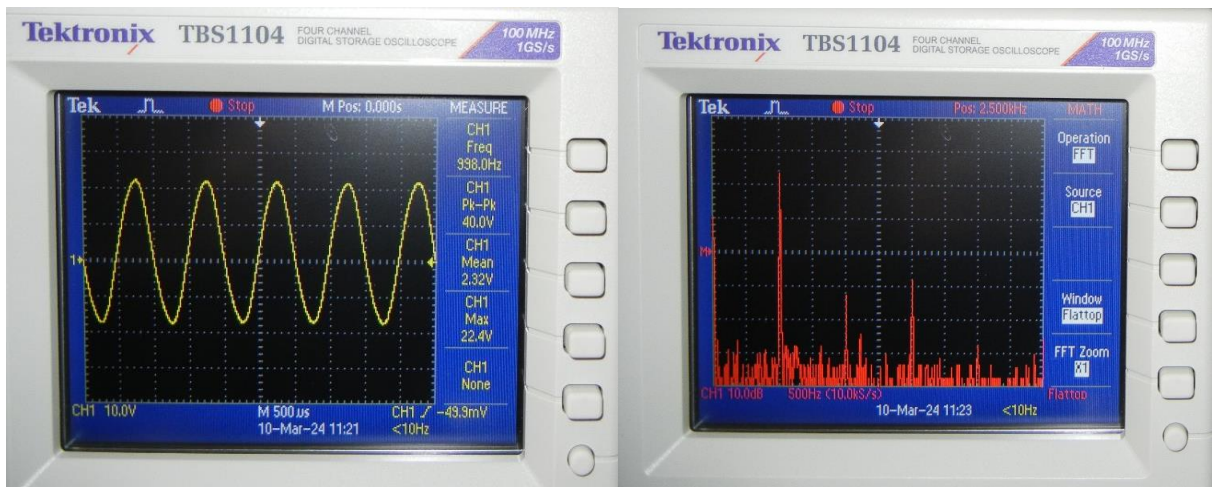
7. The demodulated signal is closer to a perfect sinus with a -C battery. The oscilloscope probe is connected directly in parallel with the high impedance speaker. Following screen captures show demodulated 1 kHz signal and its spectrum (using FFT function of the oscilloscope). The second and third harmonics are as low as - 30 dB compared to the fundamental one.
