Repair of warped dial scale - Sony CRF-5090.

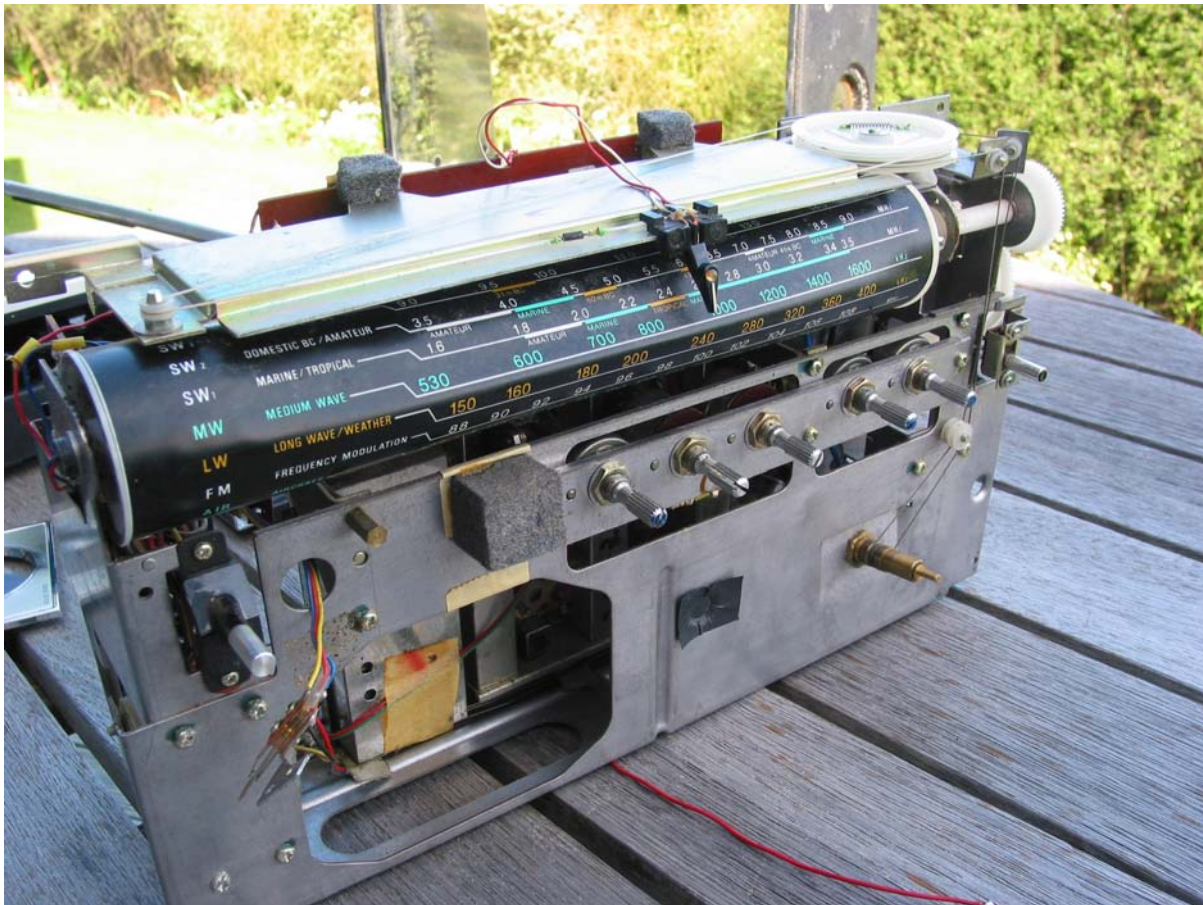
The scale appeared to be “flattened” only on one side. The previous owner said that he used the receiver only on the aircraft band and that it was always used with mains power. With the aircraft band selected, the “flat” section was uppermost. When run on mains power, the scale lamps are always illuminated, so perhaps the scale is softened by the lamp heat.

Figure 1 - the scale before removal.

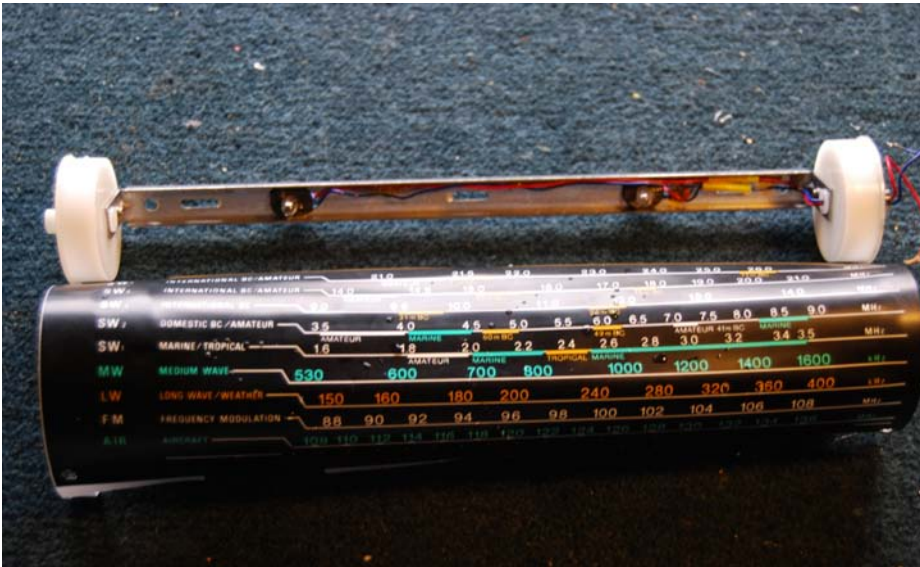
The scale is attached to the two drum ends by two self tapping screws, a melted plastic “rivet” and some double-sided tape. A small hole was drilled through the plastic “rivet” with a drill held in a pin chuck - the excess plastic was chipped away with a scalpel blade. The two self-tapping screws were removed. The double-sided tape had gone quite brittle and was carefully sliced through, again with a scalpel blade. With the scale removed, the remaining dried out glue was softened and washed away from the drum ends and the back of the scale. It was found that the scale was not affected by water, but solvents were avoided.

Fig 2 - Scale removed.

The scale can be removed quite easily after unsoldering the dial lamp leads from their tagstrip. Loosening the screws on the right hand end shaft coupler allows the coupler to be slid down the shaft. There is now sufficient space to lift the shaft out with the dial. The left hand end just sits in a hole in the mounting plate.

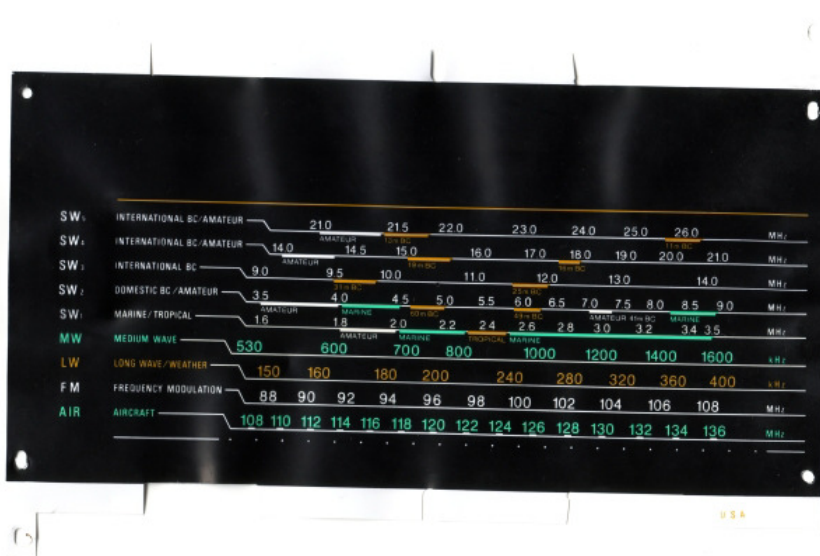
The scale was gently flattened and then scanned at 600dpi in case of accidents!

Fig 3. Scanned scale:

The scale was then placed on a flat piece of 9 ply wood between two sheets of greaseproof paper. Then with an ordinary flat iron starting on the lowest heat setting, the heat was slowly increased until the plastic softened then let it cool. Results were quite good with very little distortion apart from a slight “barrel” effect. However, on closer inspection it was found that the whole scale had shrunk slightly. By measuring the drum ends and comparing with the earlier scanning, it was found that the scale had shrunk by about 3mm in both dimensions. The now flat scale was scanned again and then enlarged by 2% - the calculated amount required to bring it back to full size. A paper print was made, trial fitted and found to be accurate.

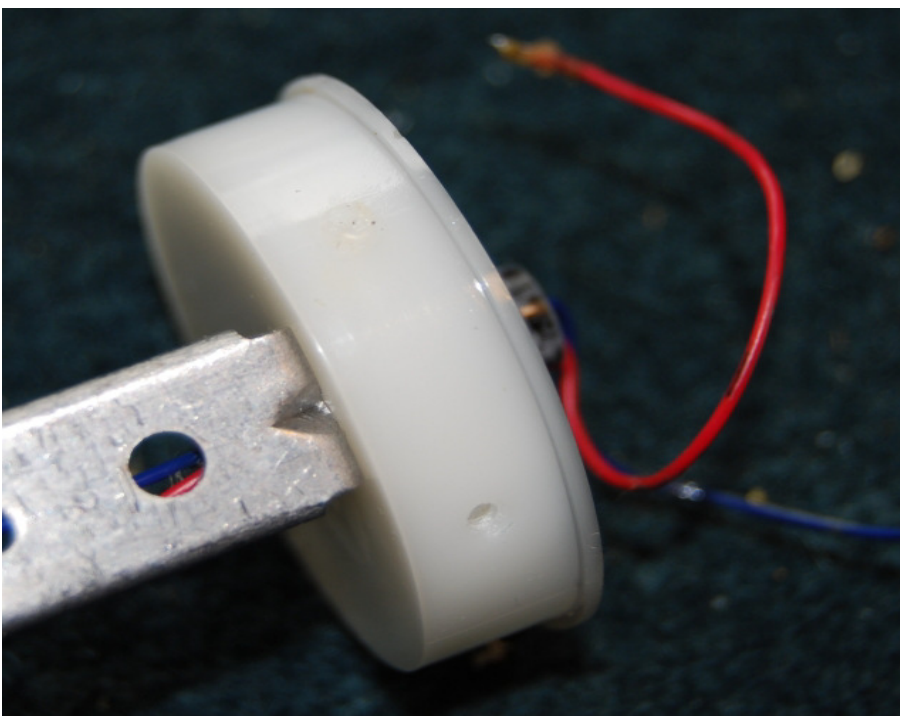
The edges of the scale were cut with a craft knife and straight edge, and made the holes square with a scalpel. (I would have liked to use a leather punch but don't own one and a paper hole punch is too big.) The holes in the drum where the plastic rivets were drilled out were tapped to fit small screws.

Fig 4. Scale drum end.

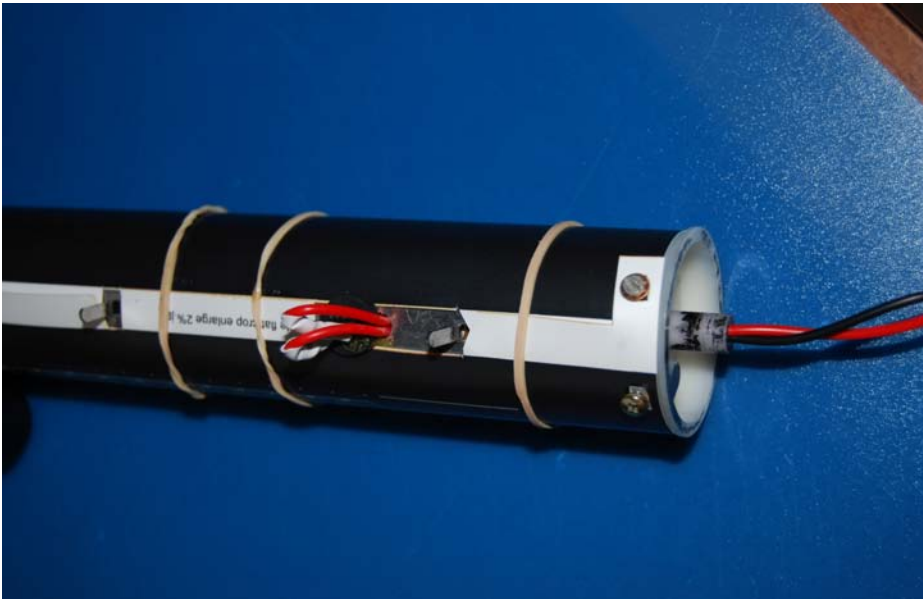
The inner end of the scale was fitted to the drums and attached loosely with (now) two screws and then fed the scale around and held in place with elastic bands. The other two screws were then fitted loosely too. The grommets holding the LED's were fitted over the ends of the scale and everything adjusted for best fit. The centre flaps were then glued down to each other with contact adhesive and allowed to dry. Using adhesive applied with a screwdriver blade, glued down the rest of the flaps to each other. Pressure was applied with more elastic bands. The small tabs were bent over.

Fig 5. Scale glued.

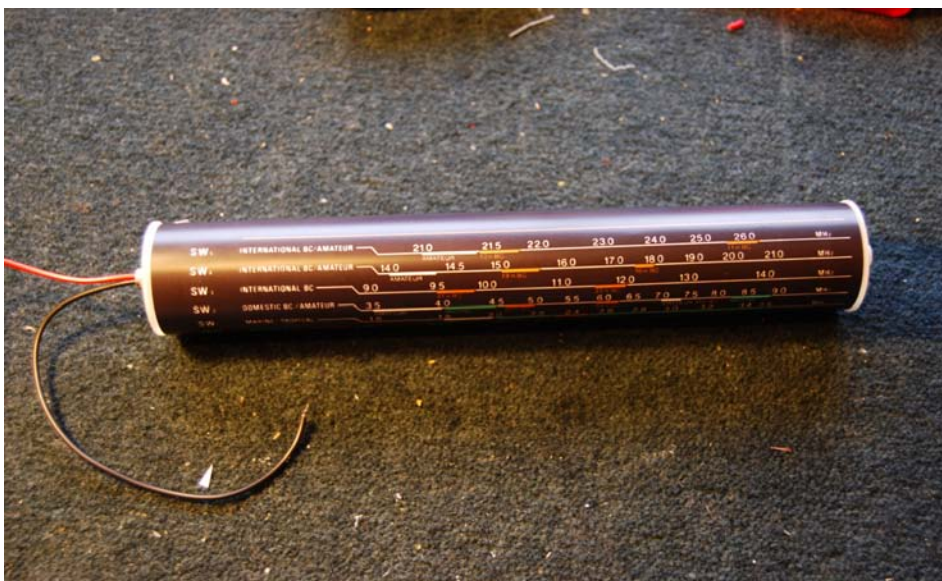
The ends flaps were then adjusted for best fit and the four screws gently tightened. As the new scale is slightly thicker than the original, it was decided that gluing of the scale to the drum ends was unnecessary.

Fig 6. Finished scale.

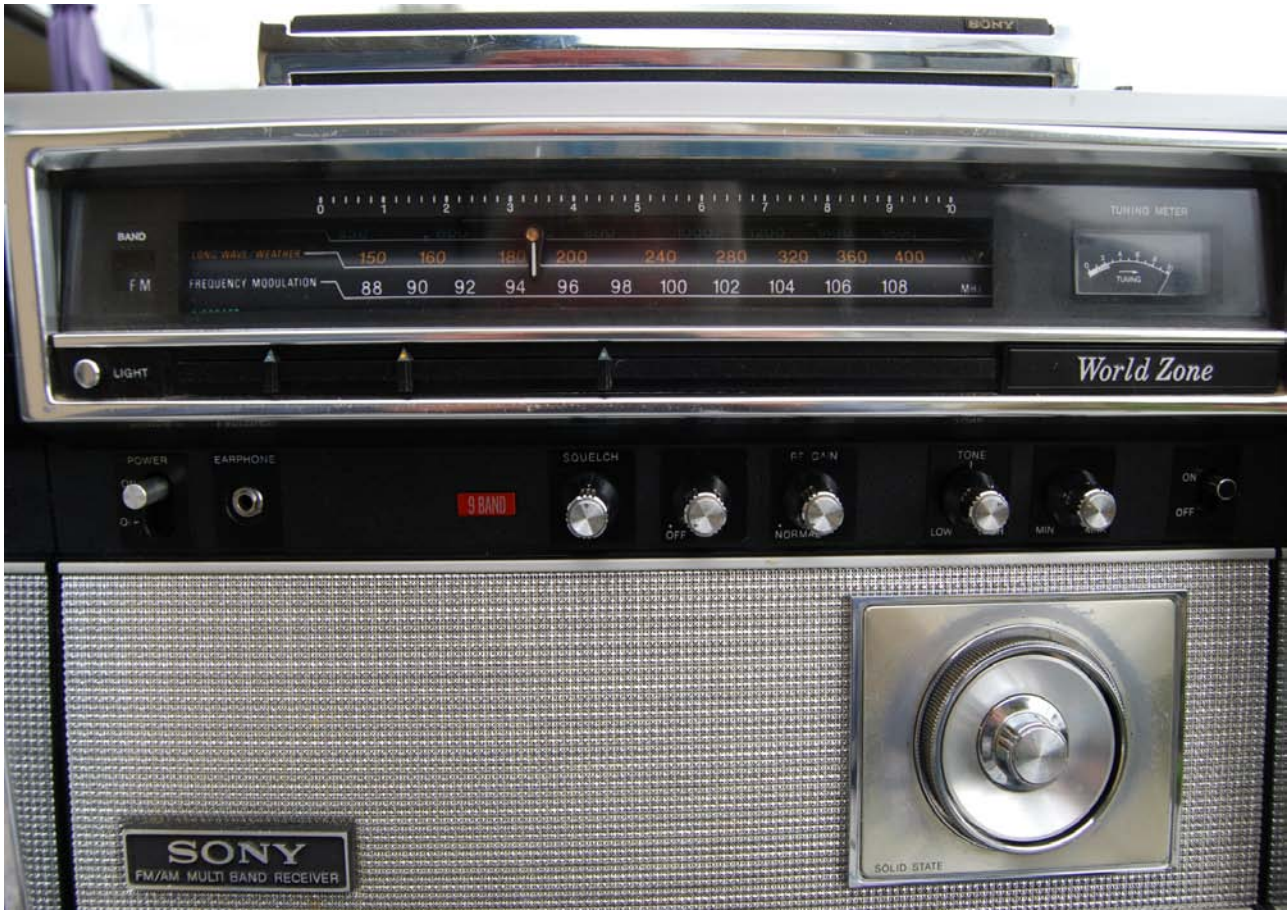
The scale was then refitted into the radio and the LED's connected. A trial run of lamp brilliance was satisfactory with the scale lightly but evenly illuminated on mains power and with adequate brilliance when the "Light" button is pushed. A check of the scale calibration showed that no adjustment was required. The chassis was then fitted back into the case and now looks really good.

Fig 7 Complete.
