MODEL 5

COLIN B. KENNEDY CORP.

Kennedy Model 5 Restoration Process

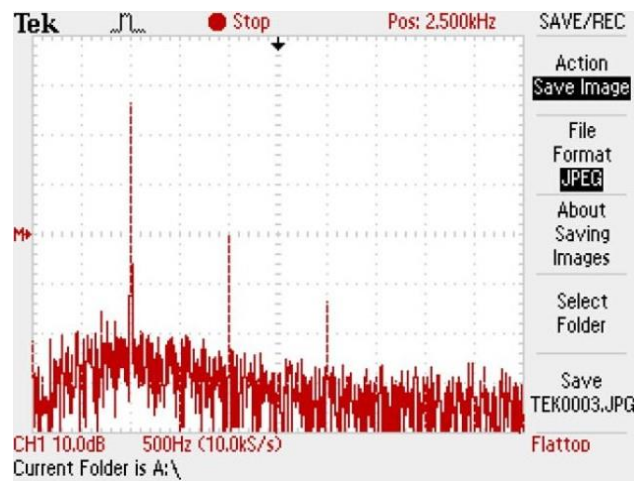
13. Test Bench includes as usual the Rohde Schwarz signal generator SM 300 and the digital oscilloscope Tektronix TBS 1104. A Micsig DP 10013 High Voltage Differential Probe connect the 2nd AF output (Speaker) to the oscilloscope. Signal generator is set at -40 dBm RF power, 1 MHz carrier, AM, modulation index 75%.

- The sensitivity is -40 dBm @ 500 kHz, -50 dBm @ 1000 kHz and -45 dBm @ 1500 kHz.**
- The AF signal is captured at the 2nd stage output. Volume signal is turned below the limit of starting auto-oscillations. The recorded signal has the **2nd harmonic at more than 25 dB below the 1 kHz tone and 3rd one at 40 dB.**
- AF bandwidth is also measured. As shown in Excel graph obtained with measurement points, the output voltage (peak to peak) versus frequency the **6 dB bandwidth is from 500 Hz to 2300 Hz**, as usual for 1920's horn speakers.

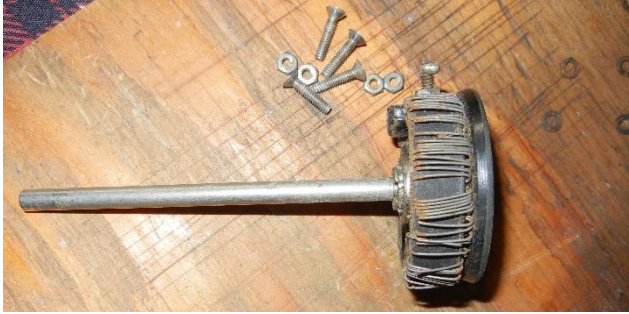
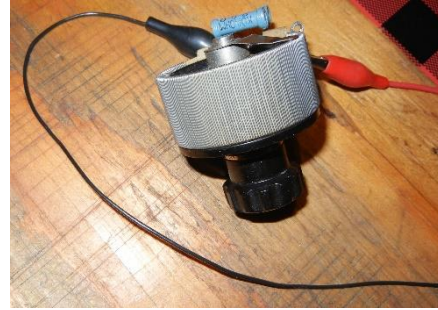
1. The chassis has been deeply cleaned with Autosol. The bakelite panel also cleaned and some inscription restored with white paint (water based, as for inside home painting).
2. The rheostat was completely rusted and destroyed. Probably a water damage, as suggested also by some very rusted screws. I have replaced by a 27 Ω wire bound rheostat in parallel with 2 x 22 Ω resistors (to be as close as possible to the original 5 Ω rheostat) and then I move it closer to the front panel due to different physical appearance.
3. The second AF transformer is OK, 1K1/ 5K1, a ratio usual in the time. The first one has the open secondary. The usual repair, in red at the secondary of the 1st AF transformer. The primary can be also disconnected and replaced by a 100 KΩ resistor connected from the green dot to 22.5 V DET voltage, in parallel with the 6 nF capacitor.

Bad (left) and replacement (right) rheostat photos are below:

- a. The straightforward method is to add in series a resistance of around 3.4 Ω/ 3 W and a switch.
- b. Another method to replace the broken rheostat is to use two 1N4007 diodes in series with a switch. According to the diode data sheet and measurements the voltage on a diode is around 0.9 V at around 0.75 A direct current (maximum is 1 A for 1N400x diode series). Therefore, on the cathode the voltage is around 6.3 V – 1.8 V = 4.5 V, a safe and close to optimal cathode voltage for the 201A tubes (from 3.8 V to 4.3 V) as tested with this regenerative radio.

- c. If the 1920's rheostat value than can be find on the market it's not the suitable one (max 10 Ω), a parallel resistor can be used with the price to lose the linearity of equivalent resistance value versus the tuning angle φ. It is important to pay attention to keep the on/off function on the rheostat, therefore the parallel resistor must be added in parallel with the input/ output of the rheostat wire.

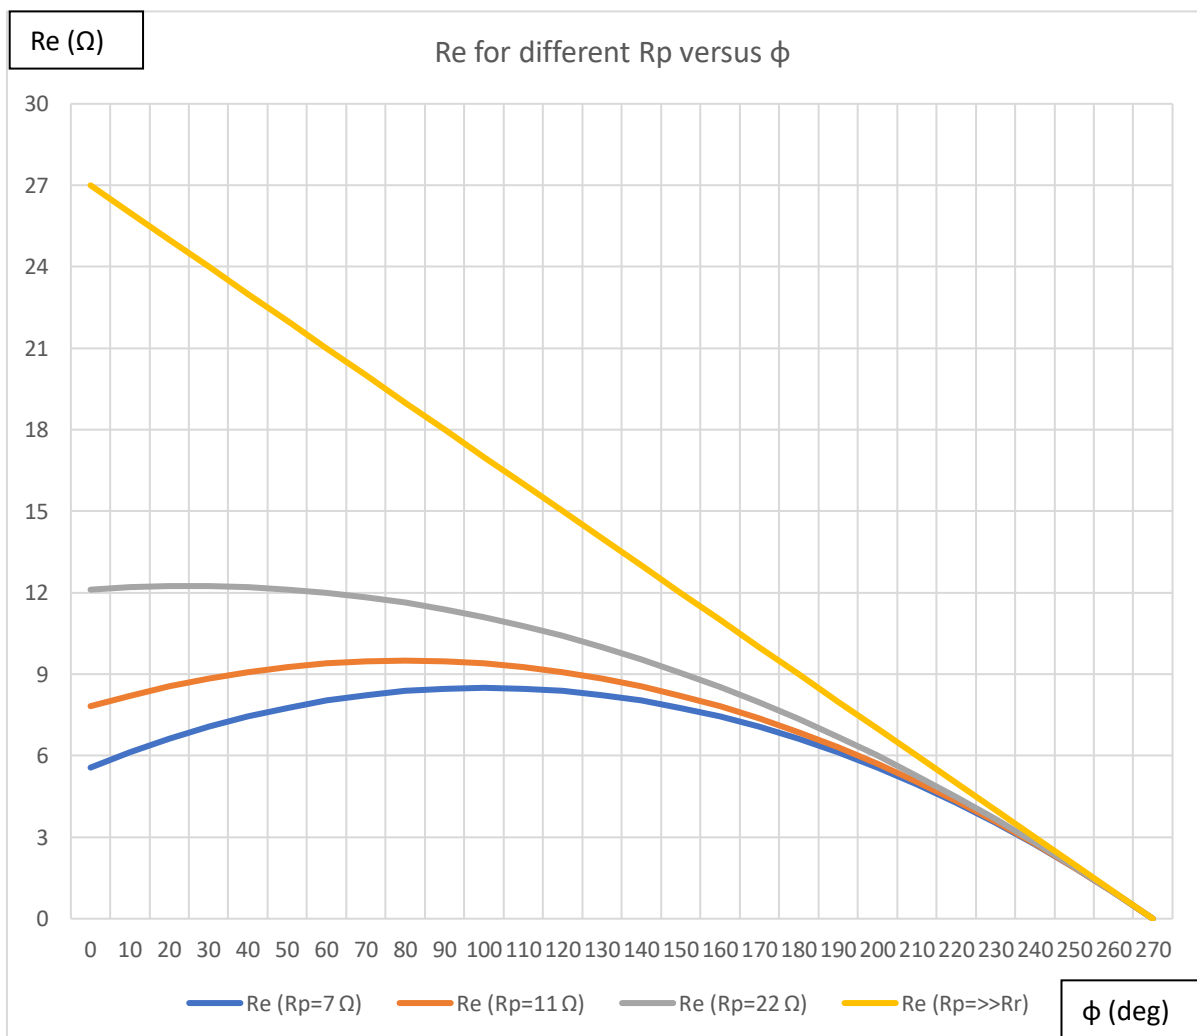
A graphical comparison of previous scenarios is illustrated in the next figure.

I have selected the $R_p = 11 \Omega$ because the maximum value is 9.5Ω , a common value for the 1920's, and also because when turning on and off the current is not too big, nor too low, and it is easy to see the tubes glowing. Like for other values, in the useful range (less than 6Ω) the variation is quite linear with ϕ and around 10° is added to the potentiometer variation stroke.

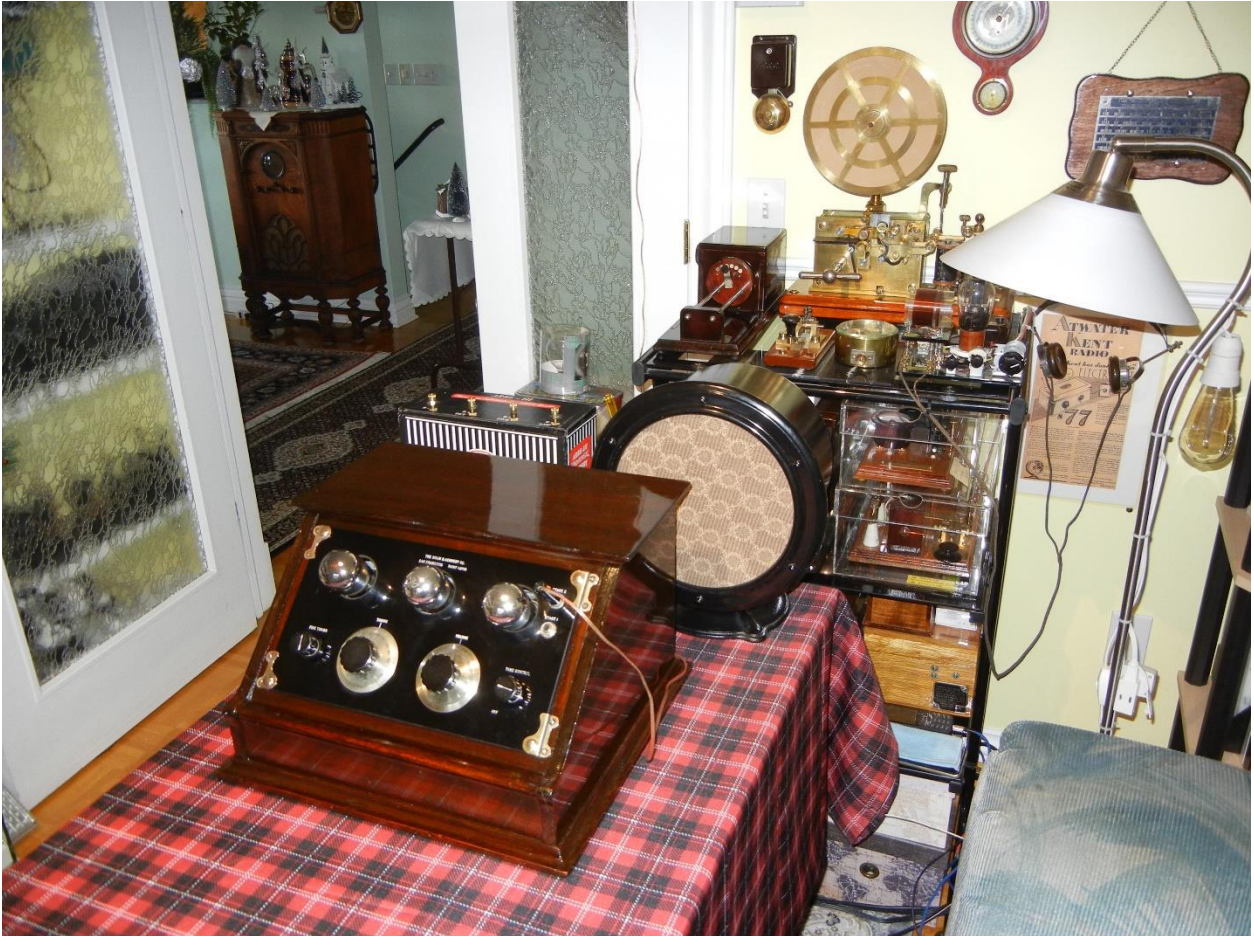
17. December 5, 2024: first long-range reception with the indoor loop antenna 1050 kHz (40 %) a New York station, ESPN. A distance in straight line of 331 miles = 533 Km. next morning and next night the station was tuned once gain.
18. The beautiful radio under test in my room: powered by ARBEIII – Universal Battery Eliminator and connected to an haute impedance speaker. On back ground some other items of my collection.
