# RADIORAMA

## RADIOLA 28

**SERVICE NOTES**  
*Instructions NS 28-1*  
(Battery Operated)

# Radiola 28 Service Notes

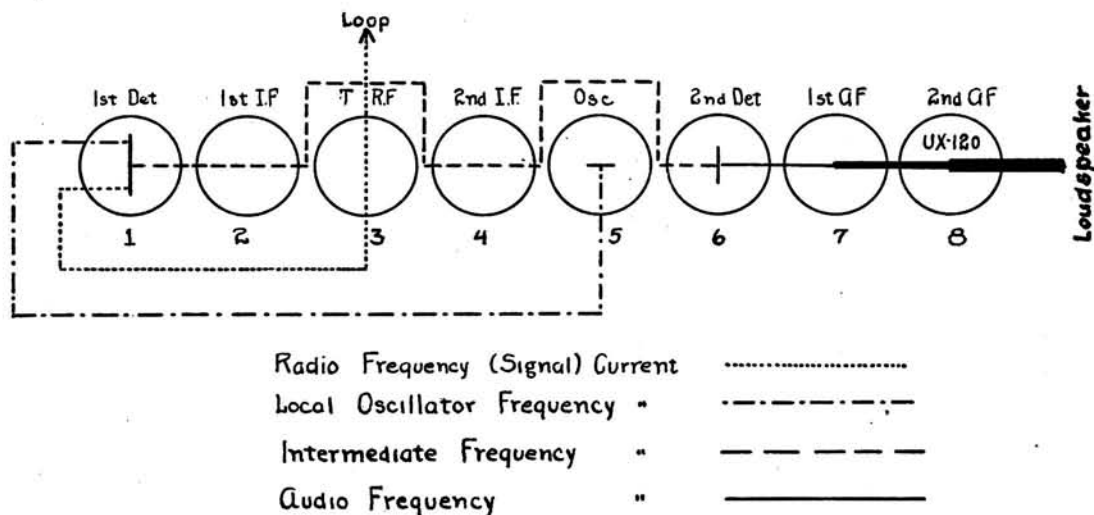
Fig. 1

Counting from left to right, the input is brought into the third Radiotron, which is a stage of tuned Radio Frequency Amplification. The output of the third Radiotron then goes to the first tube on the left, this being the frequency combining tube or first detector. The output of the fifth tube which is the oscillator is also fed into tube number one. The intermediate frequency signal now passes through tube No. 2, which is the first stage of I.F. amplification hence through tube No. 4 which is the second I.F. Stage, skipping tube No. 3. From tube No. 4 the signal is fed into tube No. 6 (skipping No. 5) which is the demodulating tube or 2nd detector, hence through tubes No. 7 and 8 which are the first and second stages of audio frequency amplification respectively. Radiotrons UX-199 are used in the first seven sockets and the power amplifier Radiotron UX-120 in the 8th position.

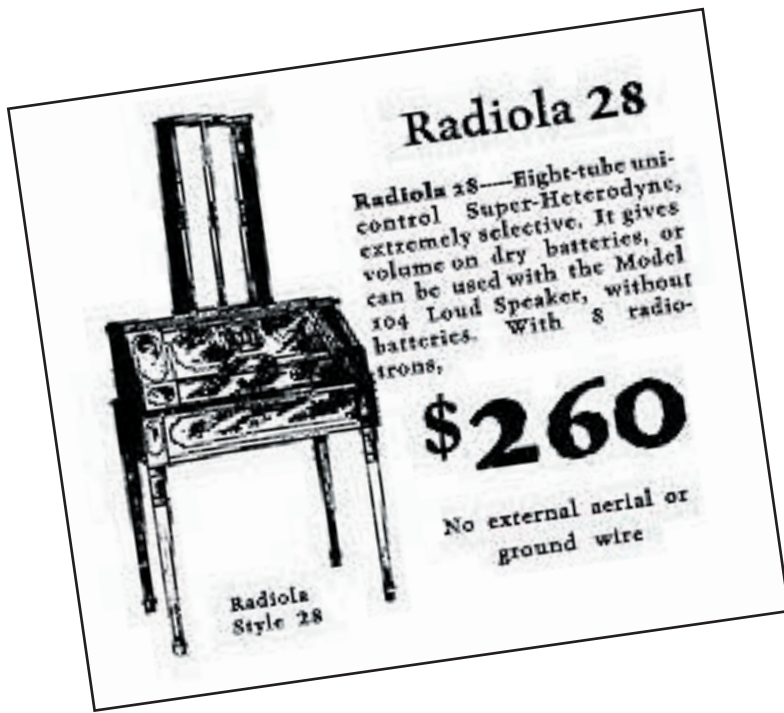
1925:  
 Der mit der aufgesetzt drehbarer Rahmen-Antenne wohl etwa mannshohe Radiola 28. Ein imposantes Möbelstück, das ausserdem noch einen Lautsprecher erfordert. Viel Aufwand für einen Mittelwellenempfänger.
